Concrete Pavement Rehabilitation Manual

May, 1992

WISCONSIN DEPARTMENT OF TRANSPORTATION
Division of Highways
Central Office Materials
Pavement Section

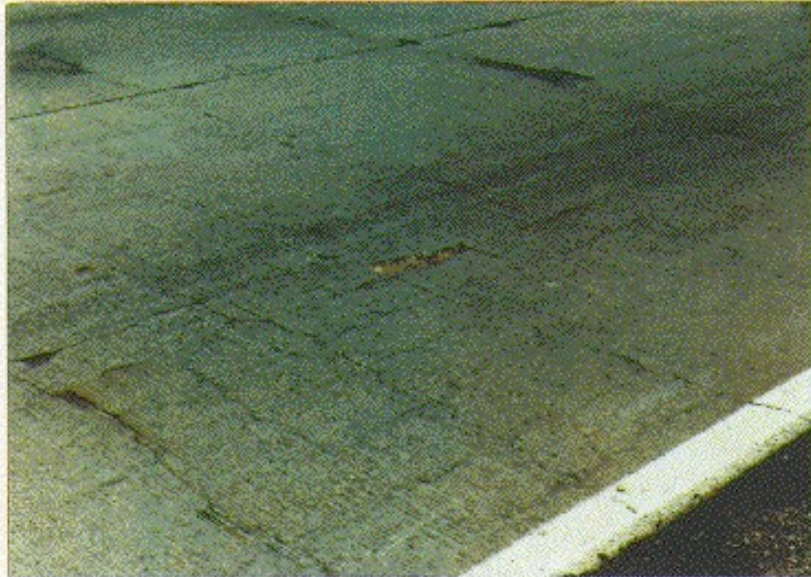
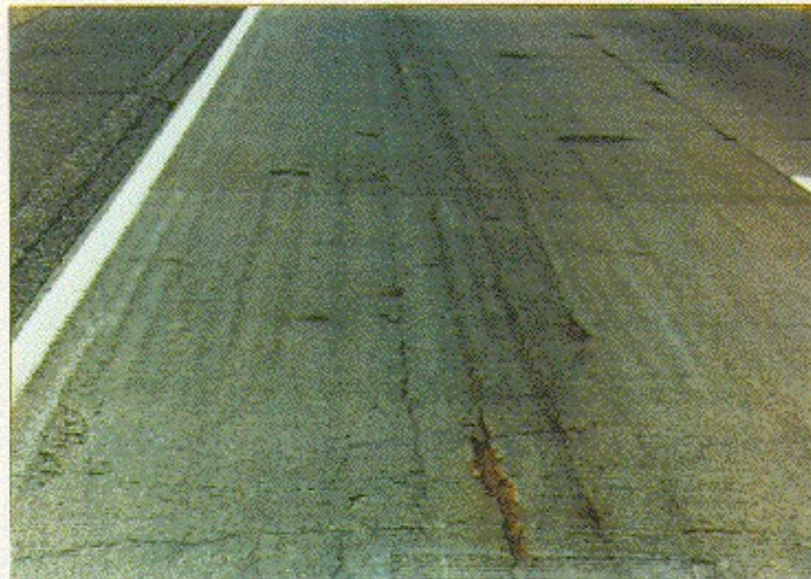
Continuously Reinforced Concrete Pavement

A full depth repair is required at this location regardless of rehabilitation strategy. The punchout failures at the centerline and far lane must be repaired prior to placement of the asphaltic concrete overlay.
